RESEARCH MEMORANDUM

CYCLIC ENGINE OPERATION OF CAST VITALLIUM TURBINE BLADES

AT AN EXHAUST-CONE GAS TEMPERATURE OF $1440 \pm 20^{\circ} \text{F}$

By Charles Yaker and Floyd B. Garrett

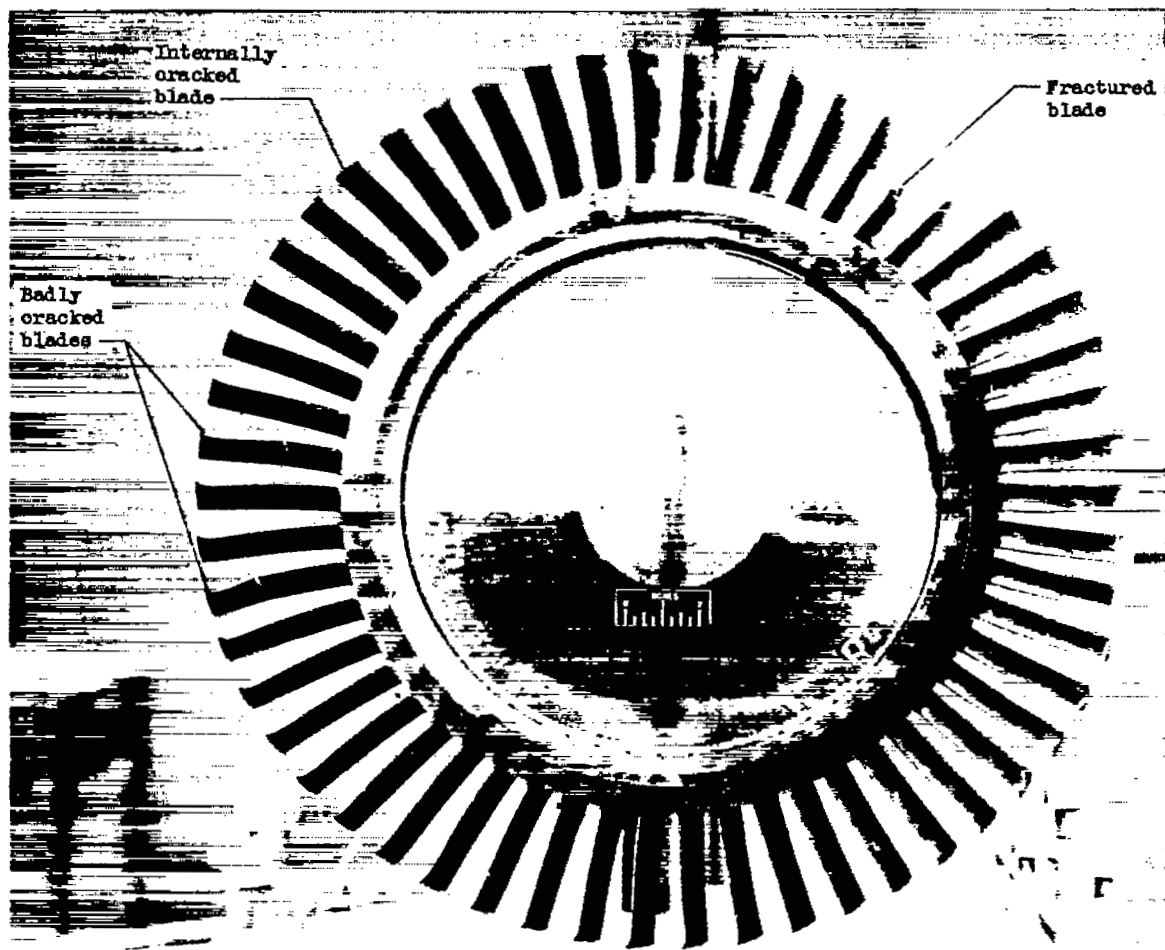
The condition of the four blades that were considered broken because they showed large cracks through the thickness of the airfoil section is presented in table I. The turbine rotor at the conclusion of the run is shown in figure 2; the fractured and cracked blades are shown in figures 3 and 4, respectively.

Figure 2. - Turbine rotor after $7\frac{1}{2}$ cycles (2 hr, 30 min) of operation.

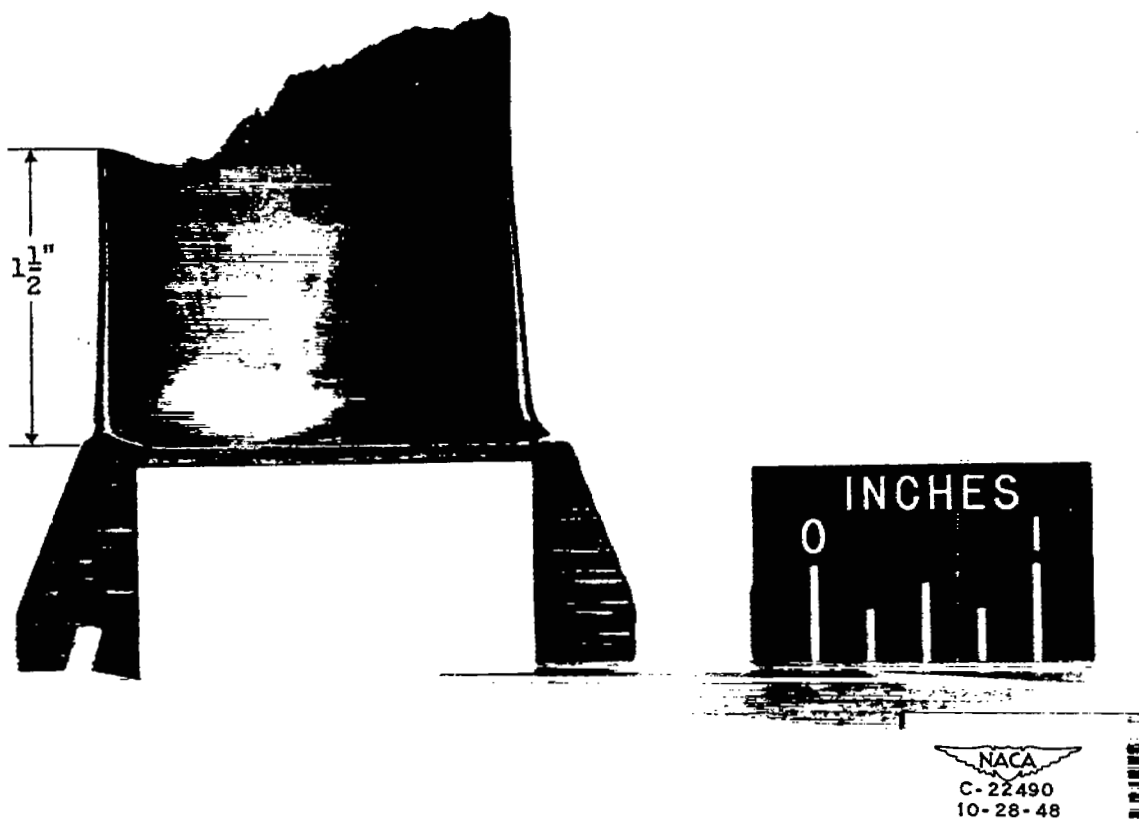
2. At the end of $7\frac{1}{2}$ cycles, one blade fractured by a fatigue mechanism. Two blades had large transcrystalline cracks, which did not appear to have been caused by fatigue. One blade had a large internal crack and 31 of the 54 blades had small cracks, all of which were intercrystalline. All blades showed evidence of grain distortion, which resulted in an "orange-peel" effect on the blade surface.

Figure 3. - Failure path across fractured blade.

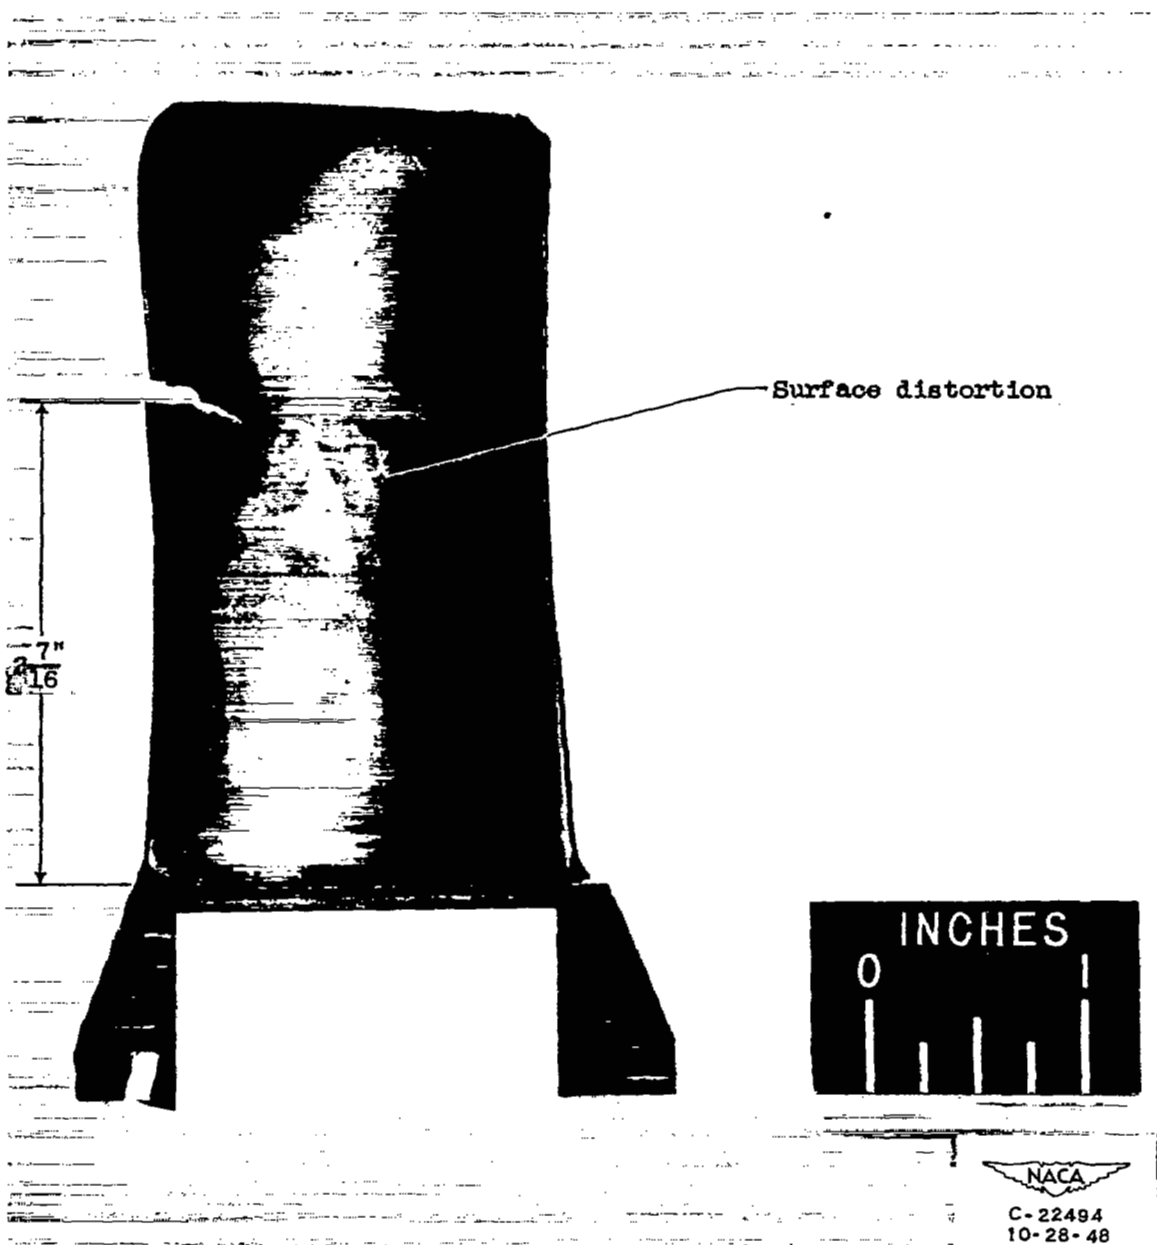
Results of the microexamination of the two blades having large transcrystalline cracks in their trailing edge indicate that they apparently failed by some different mechanism.

Figure 4. - Blade with large crack in trailing edge. Note surface distortion.

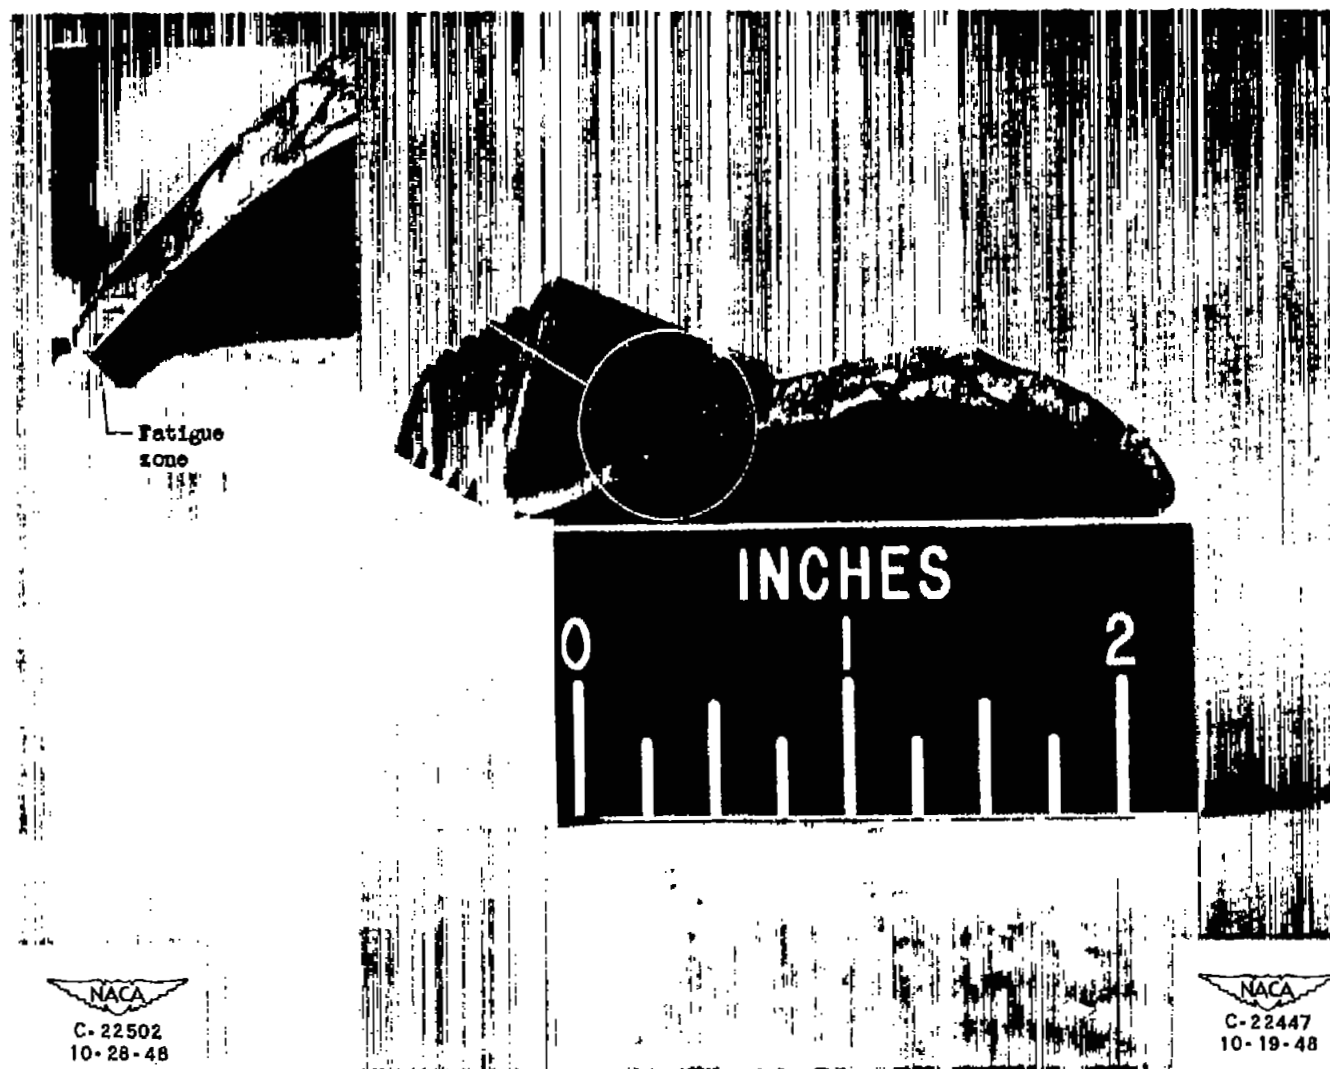
Visual examination. The blade surfaces were coated with a dark gray oxide and showed surface irregularities, which appeared to have been caused by a relative shifting of grains. Small cracks were visible in many of the blades away from the leading and trailing edges. The failure surface of the fractured blade (fig. 6) exhibited three distinct zones. The zone at the trailing edge was covered with a dark gray oxide and had the smooth surface typical of fatigue fracture, that is, concentric markings through the metal about a nucleus indicating that this failure originated by a fatigue mechanism. The zone at the leading edge, covered with a blue oxide, had a coarse crystalline appearance, characteristic of stress-rupture-test failures of cast Vitallium. The central zone is one of transition between the other two zones. The fracture surface of the large internal crack in another blade was similar to the leading-edge zone in the fractured blade except that it was covered with a dark gray oxide. Large cracks in the trailing edges of two blades were coated with a dark gray oxide and were similar in texture to the transition zone of the fractured blade. No evidence of a fatigue-type failure appeared in these cracks.

Figure 6. - Fracture surface of fractured blade, X2. Insert shows trailing-edge section, X4. Note fatigue-type fracture starting at edge of blade.

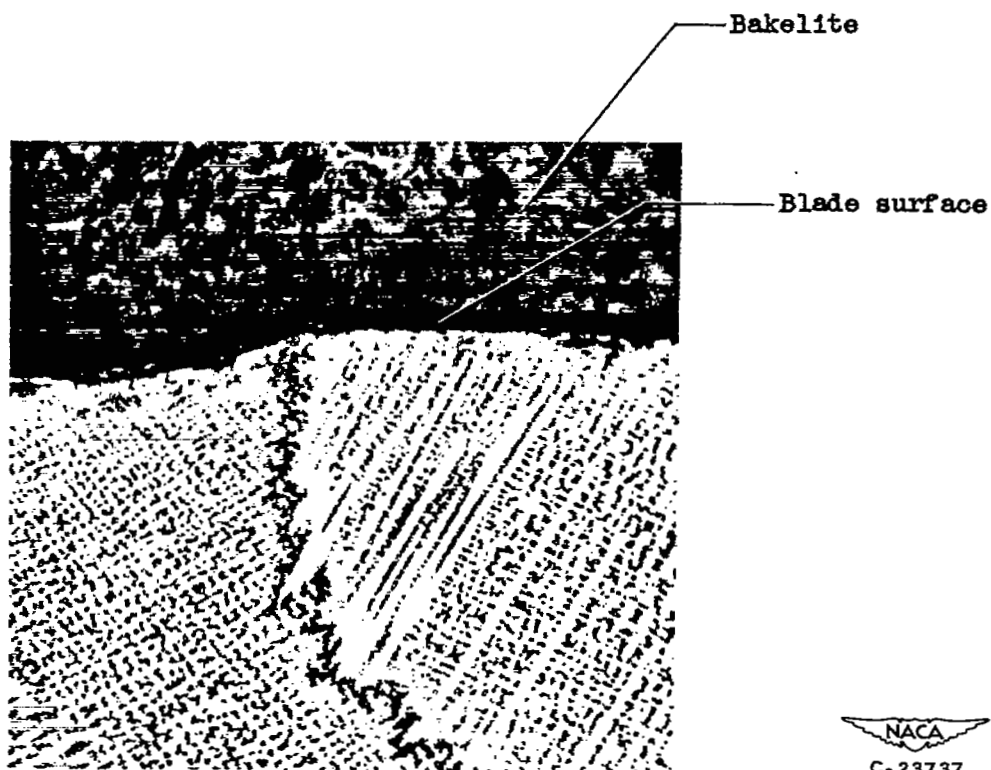
The results of the metallurgical examination indicate that the grain distortion of the blades is due to orientation differences between grains. These differences result in different magnitudes of grain slip, depending on the variation of the orientation from the preferred slip orientation (fig. 8). The blade-surface distortion is the same as the "orange-peel" or "alligator-skin" surface found in coarse-grained low-carbon steels after deep-drawing (reference 5). The orange-peel effect in steels is also due to orientation differences in coarse-grained areas. After the grains have elongated to the point where they become strain-hardened, they resist further elongation. Further stress then induces failure in the grain boundaries.

Figure 8. - Distorted grains. Structure at blade surface indicates grain movement, X25.

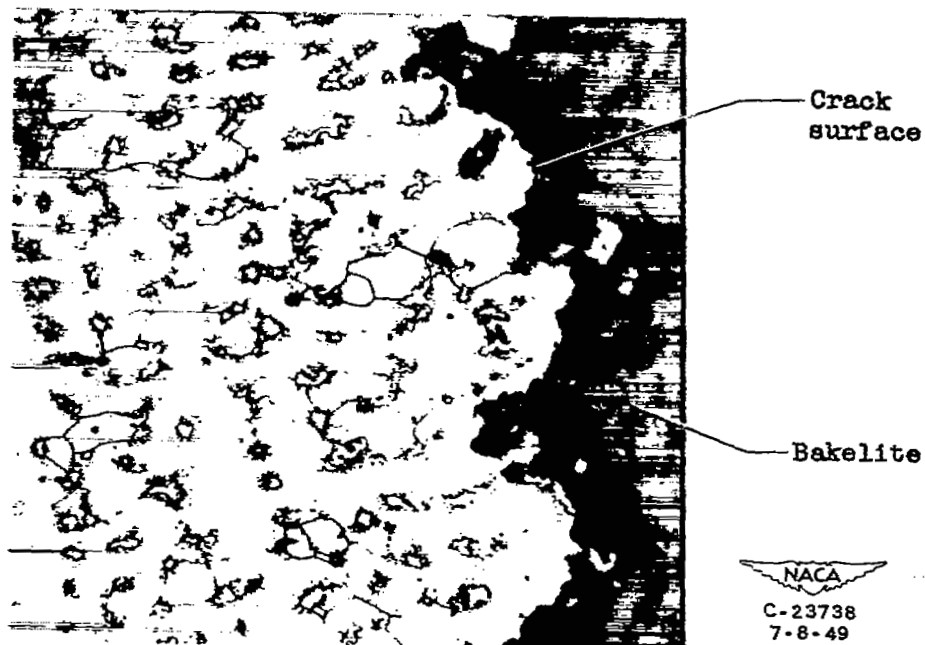
Figure 9. - Intercrystalline cracks.

Microexamination. The microstructures of distorted grains and areas of intercrystalline cracking are shown in figures 8 and 9, respectively. These photomicrographs reveal the presence of what appears to be small grains within the large primary grains of the structure. Examination of an unused cast Vitallium blade disclosed no evidence of these secondary grains except for a few scattered traces in the very thin trailing edge (fig. 10). The microstructure in the zone of the fatigue nucleus in the fractured blade is shown in figure 11. Note that a very fine secondary-grain boundary occurs in the grain at the tip of the fracture. Microexamination of the failure zones in the two blades having transcrystalline cracks in their trailing edges revealed no evidence of secondary grains. A comparison of the amount of aging that occurs along the blade during operation, as shown in figure 12, revealed that the amount of aging at the base and the tip of the airfoil section was the same with a greater amount of aging occurring in the center zone of the section.

(a) Large intercrystalline crack in blade 48, X50.

(b) Area alongside crack containing secondary grains, X250.

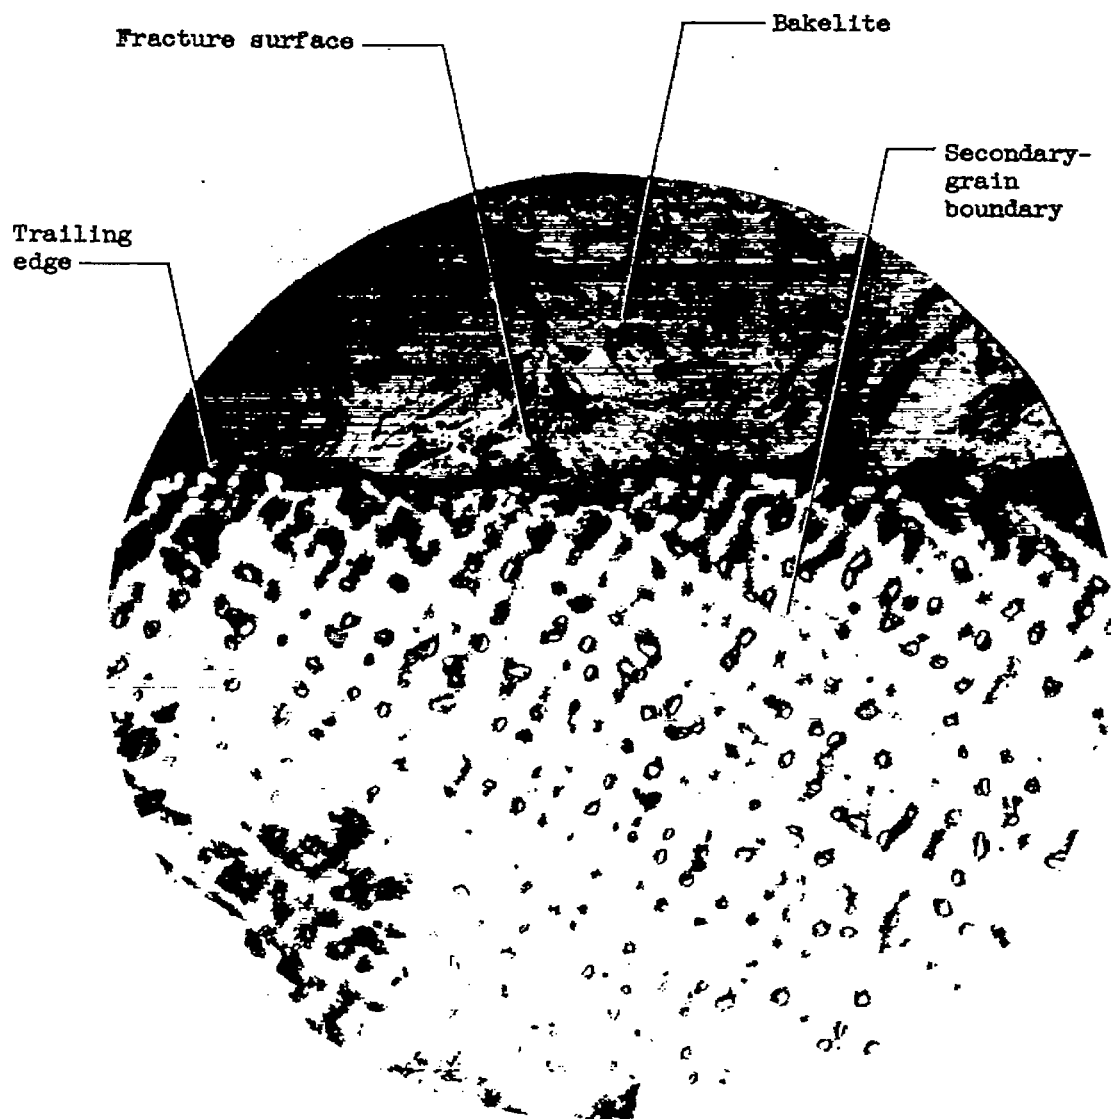
The presence of the secondary-grain boundary in the fatigue-fractured blade (fig. 11) suggests the possibility that the secondary grains and their boundaries, when present in the original unused blades (fig. 10) or formed during operation, might serve as the stress raisers that nucleate a fatigue failure. The intercrystalline cracks might also serve as fatigue nuclei. The presence of secondary grains and intercrystalline cracks suggests that, although cast Vitallium blades have a certain rupture life, they are only suitable for use to a point in the rupture life where the stress raisers within the alloy make it susceptible to fatigue failure.

Figure 11. - Microstructure in zone of fatigue nucleus of blade 6. Note secondary grain boundary, X250.

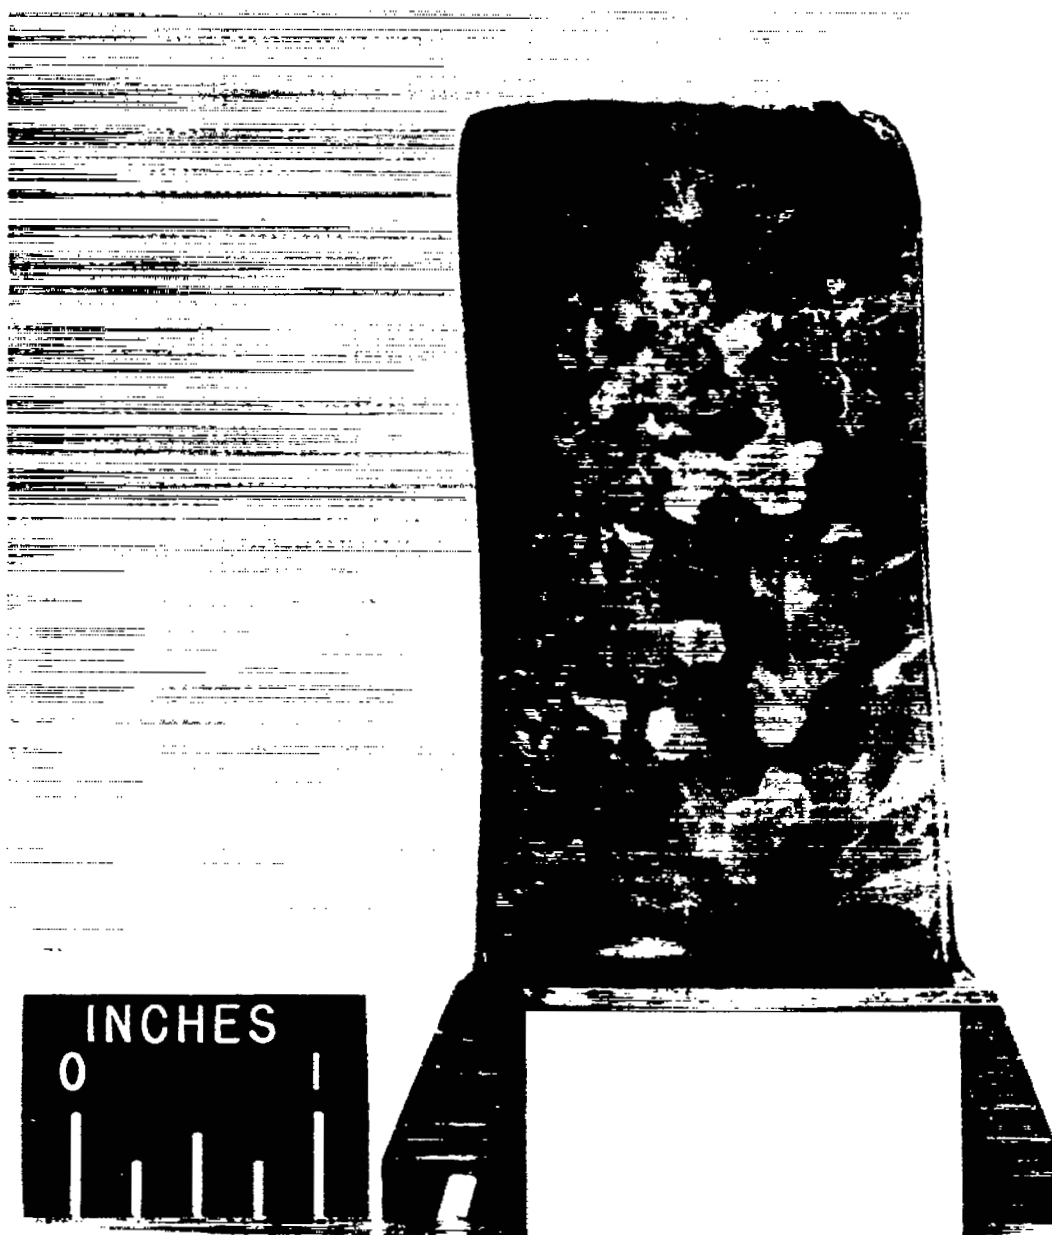
The results of the grain-size measurements failed to produce any relation between blade failure or elongation and grain size, probably because of the wide variation of grain size and orientation within the individual blades. These variations are very likely due to differences in casting variables during blade fabrication. An example of the grain-size variation within a blade is shown in figure 15.

Figure 15. - Grain structure within blade with grain-size range from 4 to 128 grains per square inch. Electrolytically etched in 10-percent hydrochloric acid.
